Keystock Interference with Drive Lug

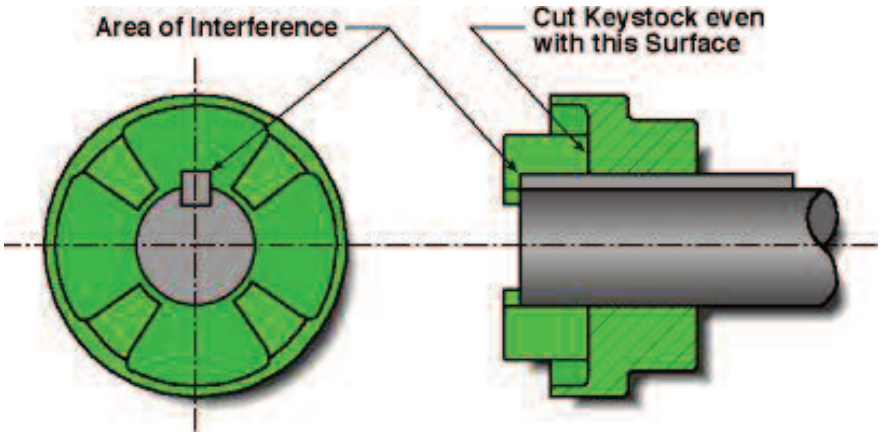
Since the Magnaloy Coupling keyway, in a bored and keyed hub, is broached between the drive lugs, there is a potential for interference with the keystock of the drive hub and the drive lugs of the opposing hub. This interference will result when ALL the following conditions exist:

A) The shaft diameter is Greater than listed below
B) This shaft extends into the hub insert core area
C) The keystock on this shaft extends with the shaft into the insert core area

Failure to correct this condition will result in assembly difficulty and could cause damage to the drive or driven equipment. ***Check our web site at www.magnaloy.com for other bulletins.***

1 The interference condition can be corrected by shortening the keystock so it does not extend into the insert core area. The insert length should be limited to the length of the coupling hub bore.
